Final Report

Rope Pump Improvement Ethiopia

Evaluation at EWTI of Rope pumps of different pump producers

Project for Rural Water Supply, Sanitation and Livelihood Improvement through Dissemination of Rope Pumps for Drinking Water (WAS-RoPSS)

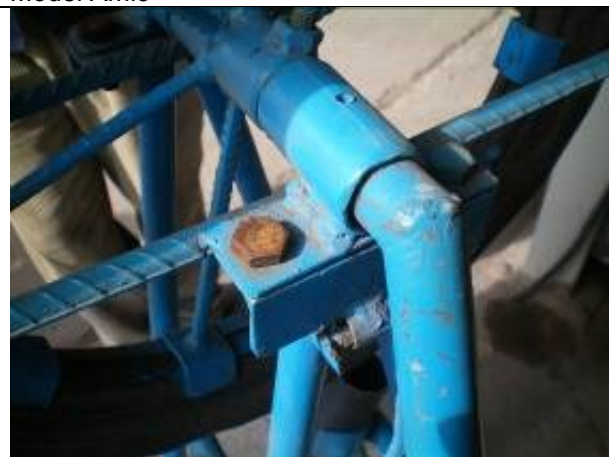
Use of black bolts instead of galvanised bolts

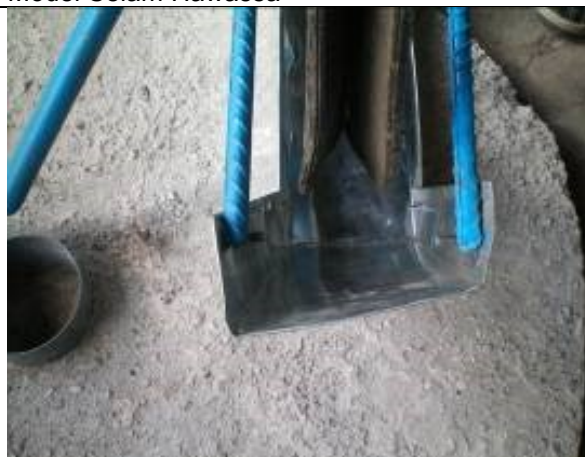
Problems with mounting of wheel cover

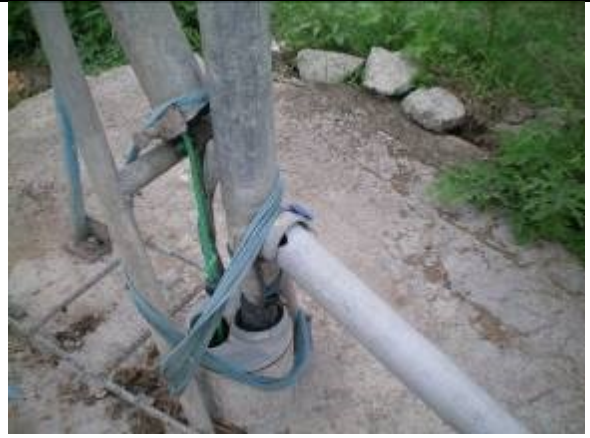
Return pipe not sealed, PVC parts broken, Pipe end cap is cut and has large holes so water leaks back in well.

- In the field survey it appeared that the cap on top of the 4 inch pipe often is of low quality or is broken so that water is leaking back there in the wells. It is suggested to make the caps and the 4 inch pipes in such a way that water cannot flow back into the wells.
- The holes in the cap for the pump pipe and return pipe should have a tight fit with the pipes.

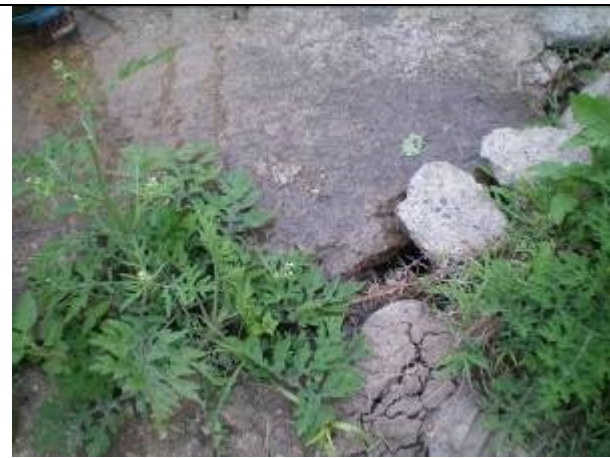
Lack of apron so water leaking back in well

- Make an apron around the slab to seal the well and avoid leaking and a soak away to avoid at all times water pools near the well.
- At some pumps the soak away pit was used as a drinking place for cattle. It is strongly suggested to avoid this since the leak water form slab and apron is contaminated. In case of cattle water it is much better to make a separate pit of bucket for drinking.

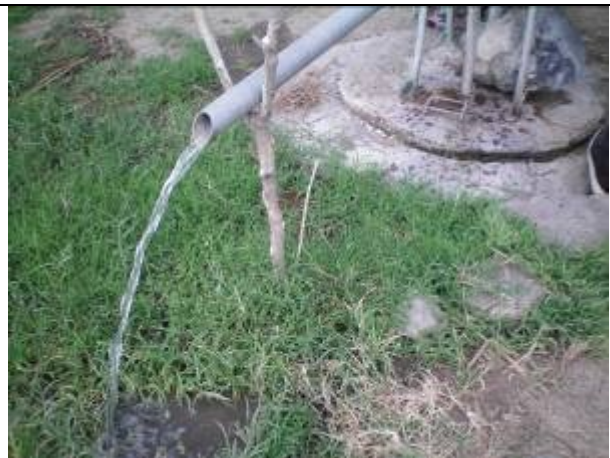
Lack of soak pit so water around the well

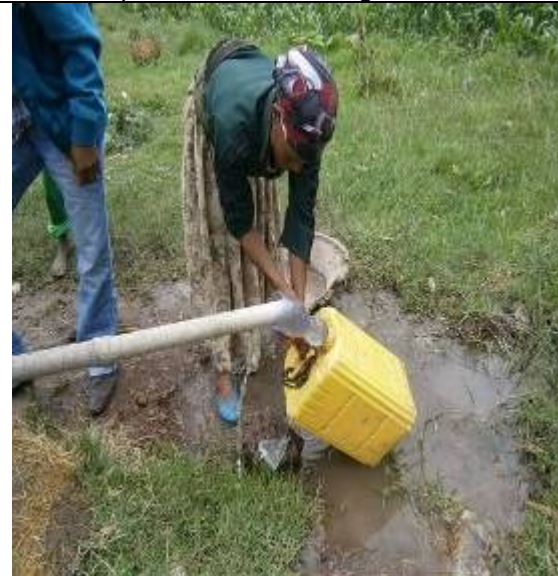
Large diameter outlet pipe so pipe does not fit into the jerrycans. Suggestion to reduce diameter outlet pipe to 1 1/4"

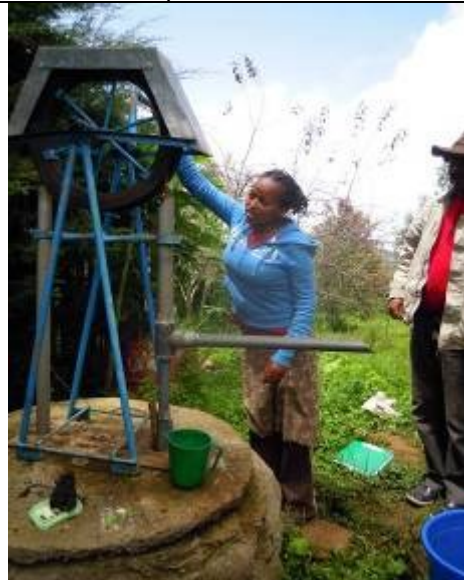
Pump high since it is mounted on a parapet. In this case short base model should have been used or a platform should be installed.

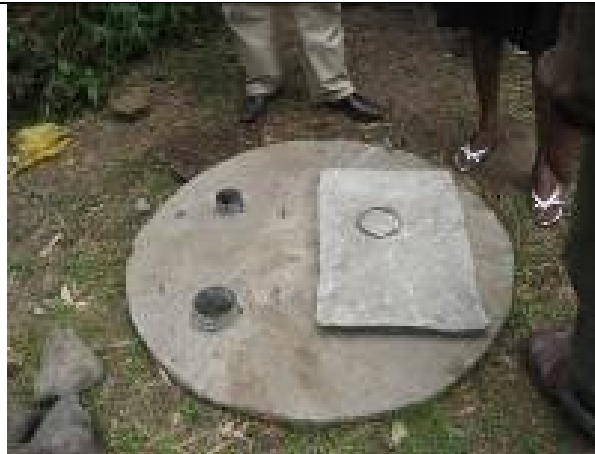
Well cover with Manhole. Water can leak back in well since there is no rim around the hole.

- The use of manholes is strongly discouraged because of water leaking back in the well. This is due to the design and often poor construction of the well cover as was observed in the field visit. In general experiences is that when there is a problem with the pump, people tend to go back to the rope and bucket and remain using the bucket which is "back to zero".

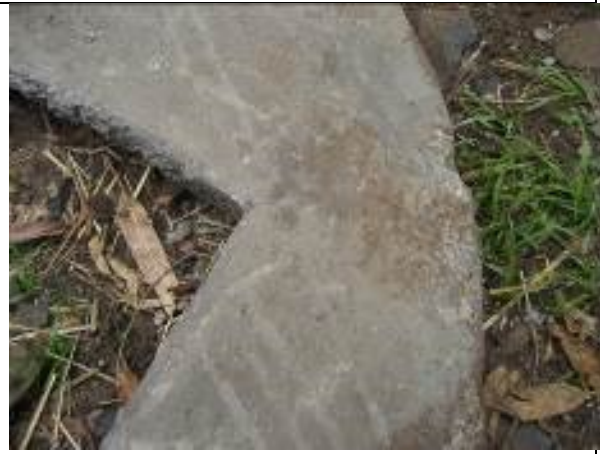
The manhole makes the well cover weak. Like in this case there is a crack cracked in the corner so another source for leaking water in the well.

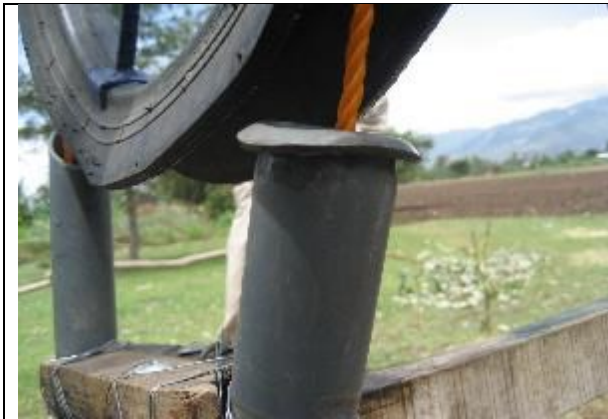
The inlet of the return pipe is not good. It requires a nice smooth entrance, a so called trumpet which can be made with a trumpet tool.

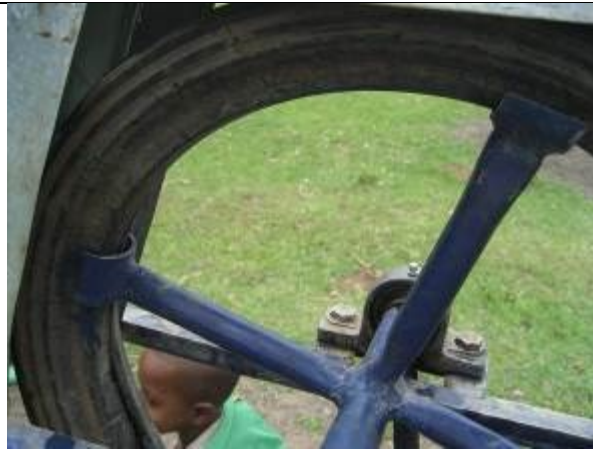
Wheel with 4 Spokes of GI pipe. Clamps in between are missing

- Some wheel clamps were loose or short so difficult to close the rings. It is suggested to make the long enough to be able to close them when rope starts slipping.
- In some pumps bolts started to rust. In general it is suggested to use only galvanized bolts. In areas where corrosion is a problem spokes can be made of ½"Galvanized pipe and the clamps of ¾"galvanized pipe, wall thickness 2.5 mm.

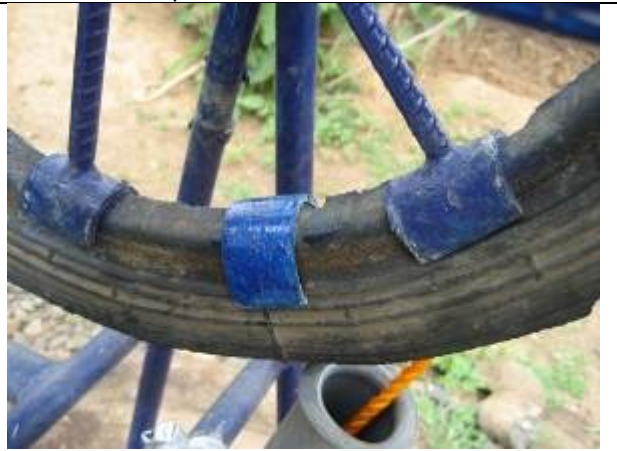
Here clamps are installed but length is not good

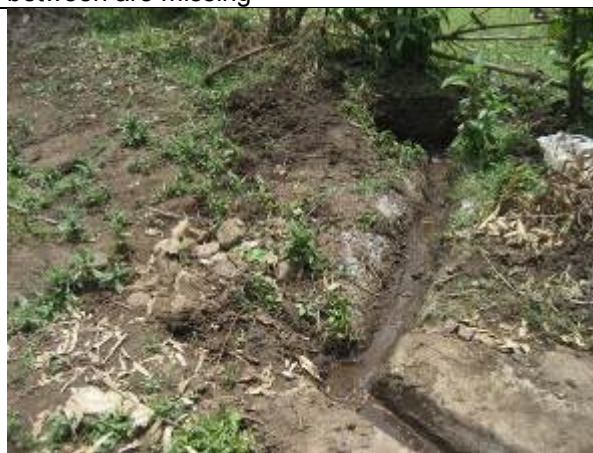
Bad example of Soakpit, The pit with stones was blocked and a new hole for cattle was made. This results in contaminated water.

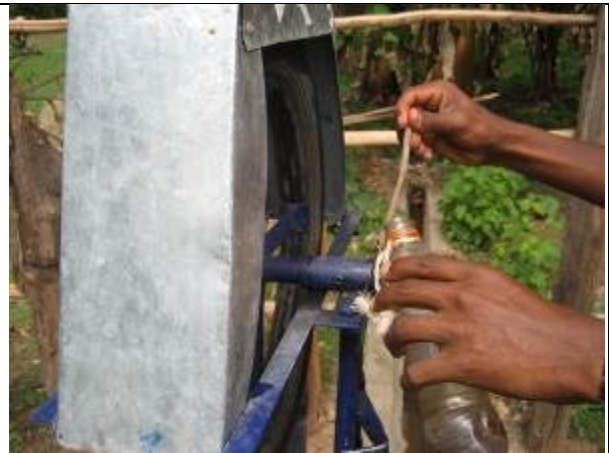
Lubrication of bushings. To make it easier oil hole should be on top
