Final Report

Rope Pump Improvement Ethiopia

Evaluation at EWTI of Rope pumps of different pump producers

Project for Rural Water Supply, Sanitation and Livelihood Improvement through Dissemination of Rope Pumps for Drinking Water (WAS-RoPSS)

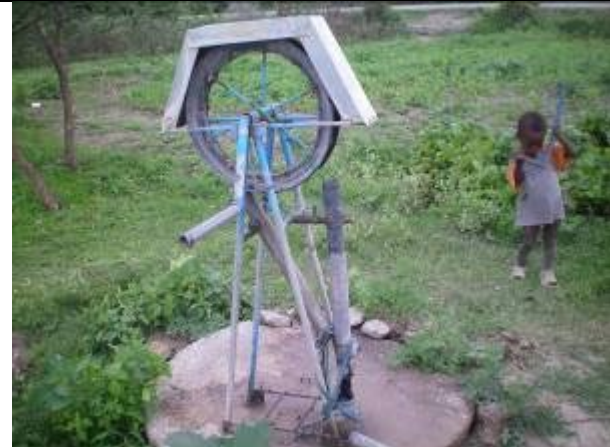
Problems in Pump installation

<p>Heavy Guidebox. New models use 60% less metal and are galvanised materials</p>	<p>Lack of oiling resulting in broken handles</p>

<p>To much clearance in bushing resulting in extra wear</p>	<p>Use of ball bearing but low quality. If ball bearing are used than sealed models with grease nipple</p>

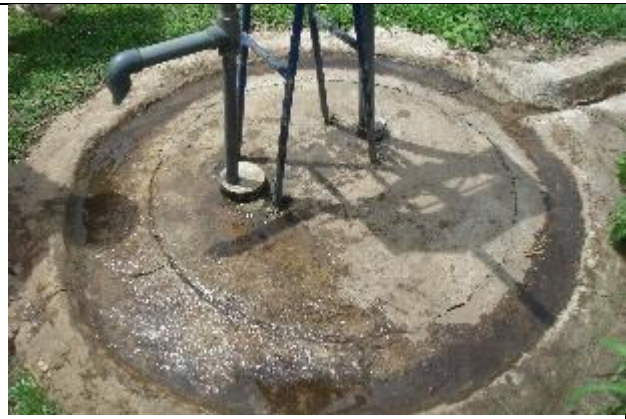
Here the well slab is not sealed well on the well rim.

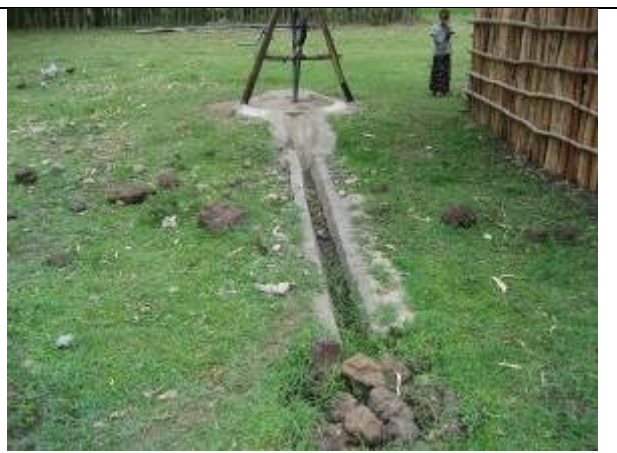
Good example of Soakpit, all water goes to the pit. The pit is filled with stones so no water is visible so not drinking of cows, no mosquitos etc.

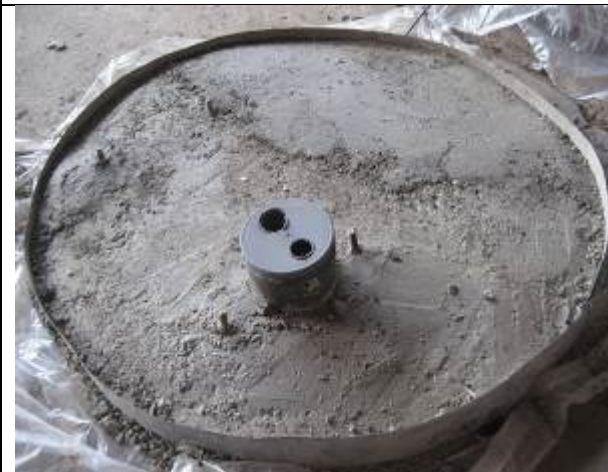
Slab of 90cm with one Hole of 4 inch
